# Manhole Inspection Summary

Manhole # S65I\_\_009MH

Insp Date: **1/8/08 1:54 PM**

**Location** Address: **550 Dundalk Ave.**

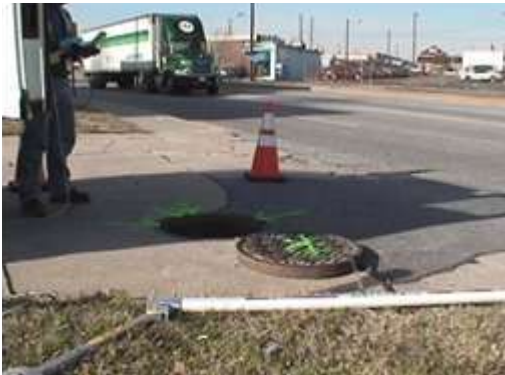
Location View

Driveway of 550 Dundalk Ave

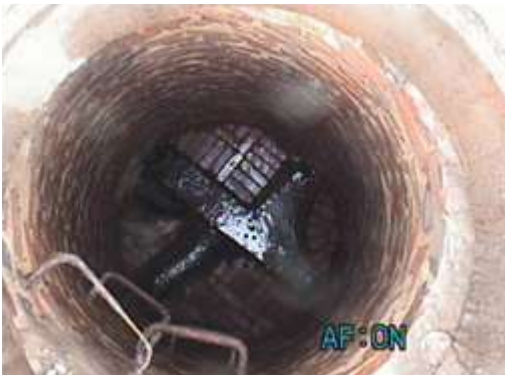
Defect 1

Offset: **2.5** (in.)

Offset frame

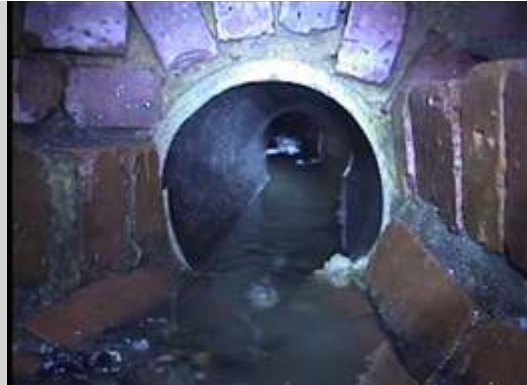
12 O'Clock Outflow

Minor debris

Deposits: ☐ None ☐ Mud ☐ Sludge ☒ **Debris** ☐ Grease

Silt Depth: **0.5** (in.) Deposits Extent: **Light**

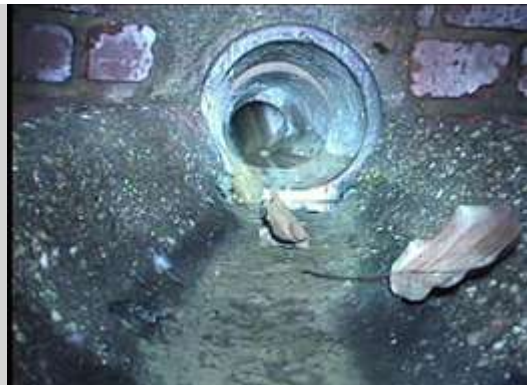
3 O'Clock Inflow

Deposits: ☒ **None** ☐ Mud ☐ Sludge ☐ Debris ☐ Grease

Infiltration: **None** Pipe Seal Cond: **Sound**

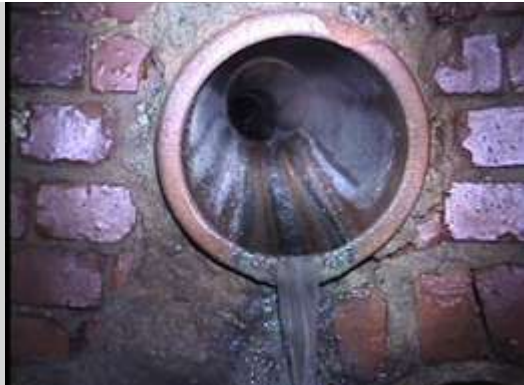
5 O'Clock Inflow

Infiltration: **None** Pipe Seal Cond: **Sound**

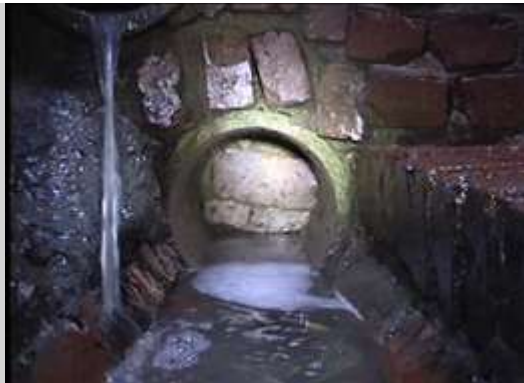
6 O'Clock Inflow

Comments **ABANDONED I6 INVERT IS ACTUALLY LOWER THAN O12.**

Connects To: **Stub connection / abandoned**

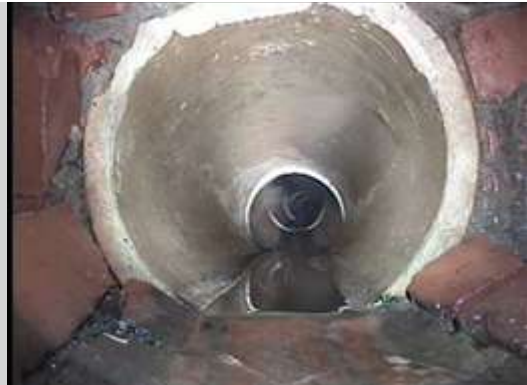
9 O'Clock Inflow

Infiltration: **None** Pipe Seal Cond: **Sound**
